# Operating Experience Weekly Summary 97-49

*November 28 through December 4, 1997*

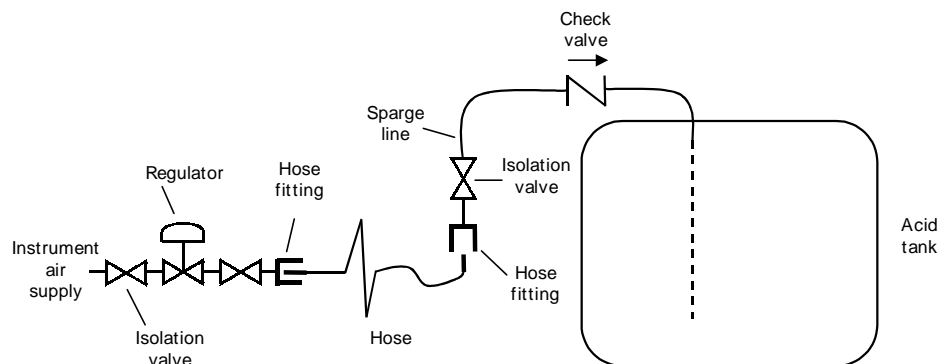
**Figure 1-1. Simplified Schematic of Air Sparger Connection**

After the work inside the tank was complete, the operations safety oversight person directed the operator to secure air flow to the air sparge line and detach the air hose at the hose fitting (see figure 1-1). Investigators determined that the operator closed the isolation valve on the tank side of the hose fitting, then closed the isolation valve nearest the instrument air source. After turning down the air pressure regulator and allowing air pressure to bleed off, the operator disconnected the hose at the hose fitting on the sparge line. When he broke the connection, he was sprayed with a foamy substance primarily containing sulfuric acid. Investigators surmised that over a period of time, acid accumulated in the air sparge line. The acid entered the air hose sometime after workers connected it to the fitting and opened the isolation valves. They also determined that the air hose was not fully de-pressurized when the operator disconnected it at the sparge line hose fitting and that the residual pressure was sufficient to force the foam-like acid out of the fitting.

This event illustrates the importance of identifying the boundaries of work zones. Despite extensive safety pre-planning and oversight, facility personnel did not recognize the conditions leading to the acid spray. This event could have had much more serious consequences. Facility managers responsible for planning work on systems containing hazardous chemicals or with flow paths connected to hazardous chemicals should be conservative when establishing work zone boundaries. Article 3 on page 5 describes another event involving an operator sprayed with low-level radiated sludge at the Savannah River Site.

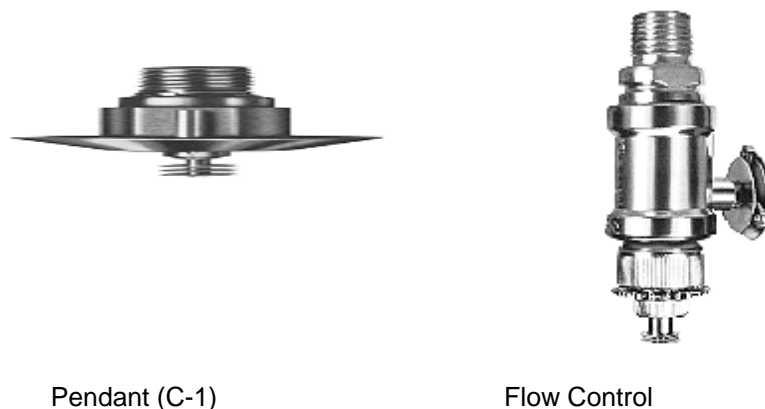
**Figure 2-1. Omega Sprinkler Heads**

Central Sprinkler Corporation determined that non-activation of the Omega sprinklers at low pressures is caused by reactions between an internal o-ring and residual hydrocarbons in the sprinkler system water from cutting oils or from improper use of stop-leak products. In June of 1996, Central Sprinkler changed the o-ring material from ethylene propylene diene monomer to silicone, eliminating the hydrocarbon reaction problem.

Figure 2-1 shows general representative samples of the Omega sprinkler. The Omega series includes models C-1, C-1A, C-1A PRO, C-1A PRO ID, EC-20, EC-20 A, EC-20 AID, HEC-12, HEC-12 ID, HEC-12 PRO, HEC-12A PRO, HEC-12 RES, HEC-20, HEC-20 ID, R-1, R-1A, R-1M, AC, M, and the flow control model used at the Plutonium Finishing Plant.

On August 13, 1997, Underwriters Laboratories issued a press release strongly urging property owners whose buildings are equipped with Omega sprinklers to immediately submit samples of the sprinklers to Underwriters Laboratory or Central Sprinkler Corporation for operational testing. Although other manufacturers make similar-looking models, Omega sprinkler models are generally identified by their three circular heat collection fins.
